PROJECT OVERVIEW

On January 22nd 2026 Chris Egnatz (Architect) performed a comprehensive structural review of the Clyde Park Town Hall and (vacated) Methodist Church properties. The following report captures the site observations and structural assessment of both properties for the town's consideration.

STRUCTURAL OVERVIEW

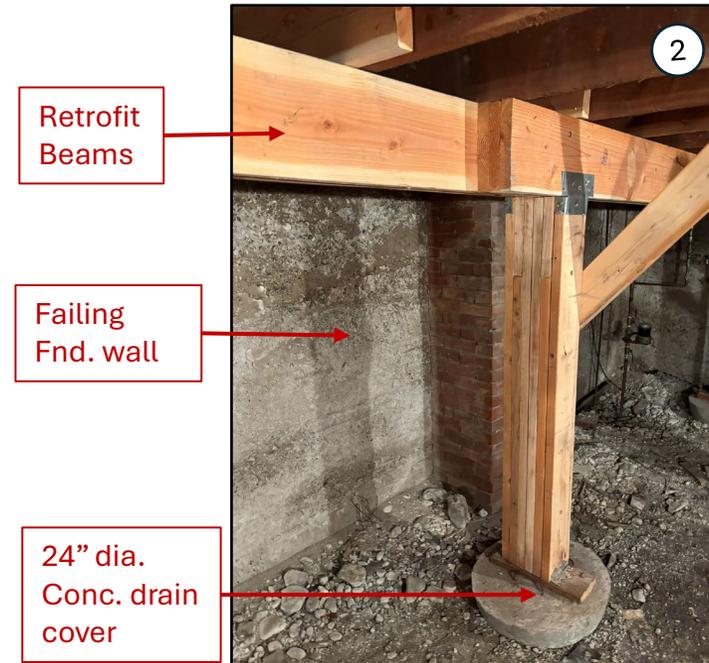
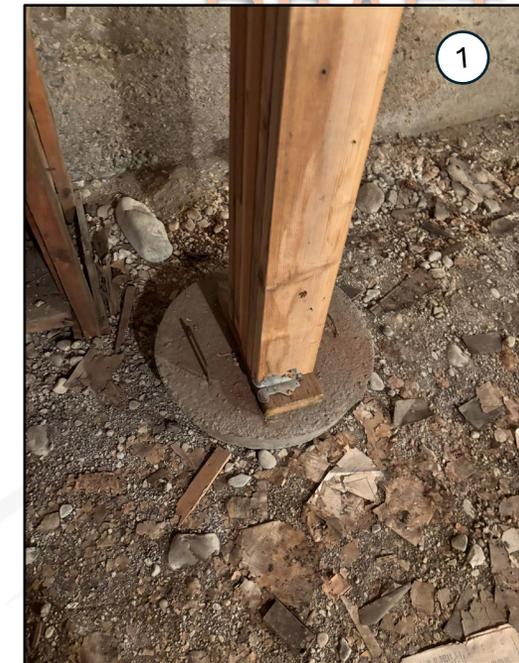
1 FLOOR JOIST RETROFIT (North)

Rough Sawn 2x10's floor joist @ 16" o.c., appear to be original and are no longer supported by the concrete foundation walls. (2) beams were added (East to West) adjacent to foundation walls (+/-15 years) ago.

These beams sit on columns supported by 24" dia. x 6" precast manhole covers. These covers act as "footings" but are not to code. Columns should be supported by cast in place footings over compacted structural fill.

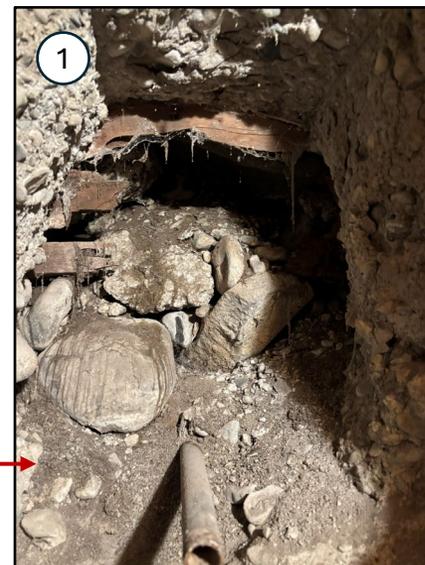
Filing 1x4 framing w/ tar paper. This is in place to retain front sidewalk and fill

The West Foundation walls is failing similar to the north wall. The floor structure was retrofit and cut away from the foundation and is now supported by columns on 24" conc. drainage covers.

However, the front façade and roof are supported by the foundation walls and susceptible to collapse if the foundation fails. Additionally, the wood framing that holds back the curb and fill at the front of the building is undersized and shows signs of water infiltration and rot. Similarly the stem walls which support the recessed vestibule show signs of degradation and water damage.

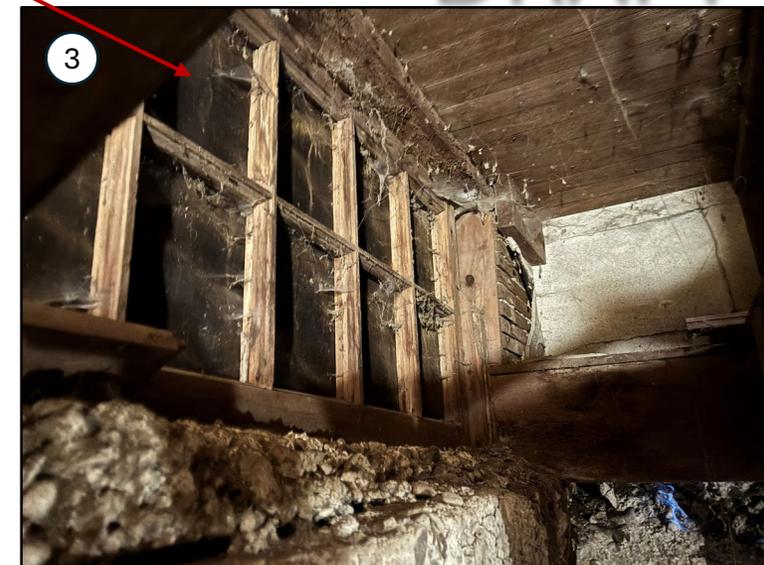
Example of failing concrete wall

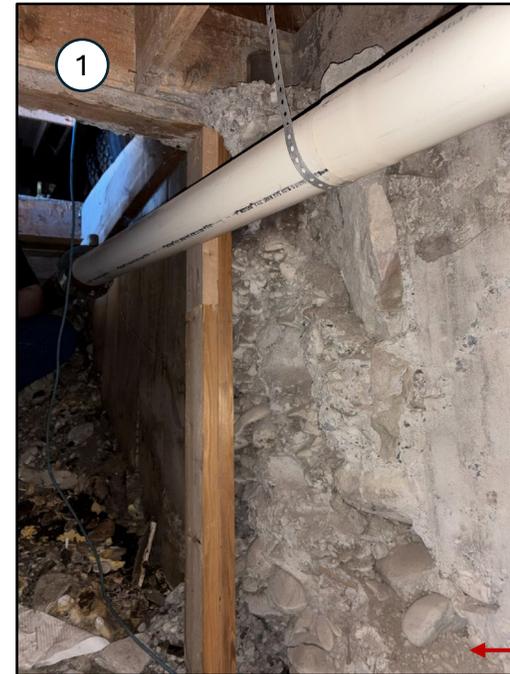
④ CUT FOUNDATION WALL

The foundation wall that supports the west side of the building was cut some time ago to gain access to the crawl space. Unfortunately, the foundation wall now non-structural and leaning in. Retrofit 2x6 framing is (hammered into place) and inadequate to support the floor loads above. Additionally, the fill supporting the fire station slab is falling into the crawl space creating a void space under the slab.

Door jack has been hammered into place to hold back fill from fire station.

Original foundation wall is now leaning into crawl space and is non-structural

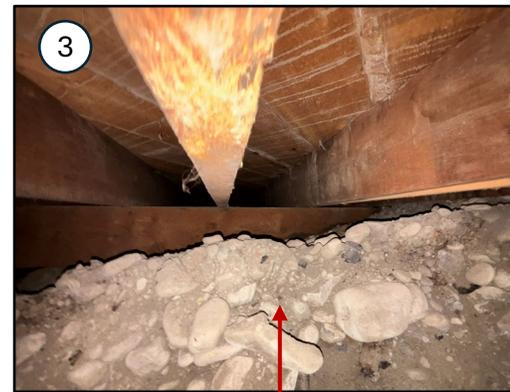
⑤ FLOOR JOIST IN CONTACT WITH FILL

There is no vapor barrier located over the crawl space where wood member are in close proximity to dirt. In some instances untreated joist are laying on, or encapsulated in dirt. We could not gain access to review what the joist bear are bearing on (if anything). However; It can be assumed that compromised joist + lack of bearing are leading to the sloping floors found in the offices above.

Example wood floor framing sitting directly on dirt.

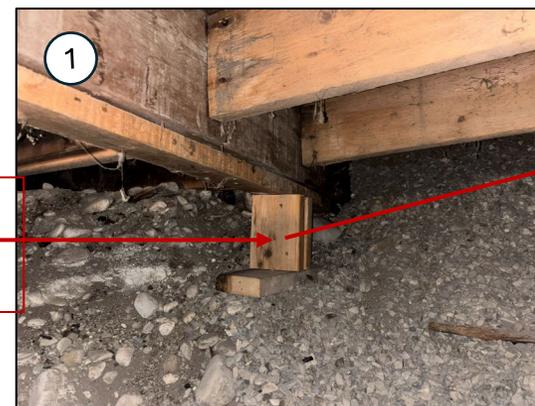
6 FLOOR FRAMING BEARING ON FILL

The east end of the Town Hall is a mixture of wood framing and slab on grade. With this hybrid construction there is differential settlement telegraphing thru the structure causing the floors to slope in the offices above.

Some time in the past this floor framing was added which rests on the original foundation wall and dirt/fill to the east. Its important to note that framing in the area of the building is inadequate. Column are hammered into place on 2x4 blocks placed on non-structural slopping fill. All column should bear on Concrete footing / sono tubes and be treated.

Beam supported by 2x6 on non-structural fill

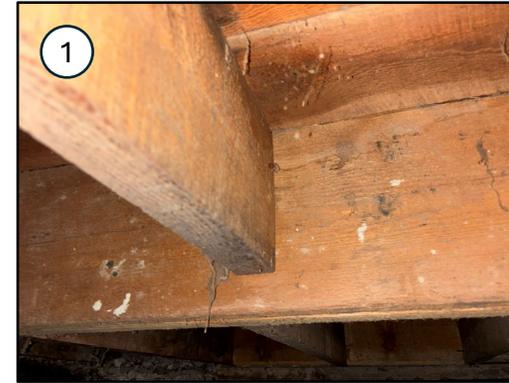
7 JOIST HANGERS

There are no joist hanger used in this area of the building. Joist have been toe nailed to beams with 8d and 16d framing nails. These fasteners can fail in shear over time from standards live loads above. Would recommend a review of wood joinery and the addition of joist hangers.

Floor joist toe nailed to beam. Fasteners can fail under shear with live load above

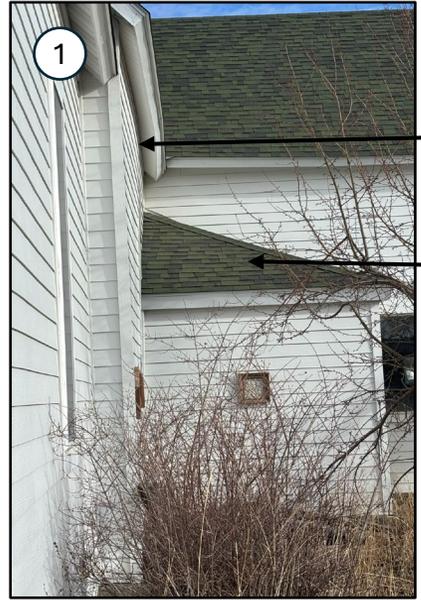
Noticeable wall bow here

Roof Rake is curving

3 THE NAÏVE (NORTH WALL) is leaning outward toward the park. This is Observable as you look down the exterior wall and can be seen from the park as a Bow in the roof ridge. The roof trusses are fastened to the top plate of the wall, as the wall leans out the fasteners and framing members are stressed. This failure is noticeable as the aforementioned bow in the roof ridge seen from the park.

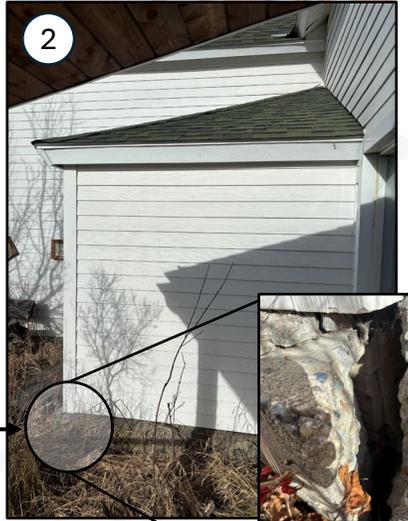
Large cracks in corners of foundation

4 FOUNDATION CRACKING There are multiple cracks in the stem wall surrounding the oldest (Naïve) portion of building. Moisture is penetrating these cracks and natural freeze thaw cycles are further cracking the foundation. Additionally, water is seeping into the soils around and under the building. This water is limiting the bearing capacity of the soils which were likely not properly compacted during the original construction

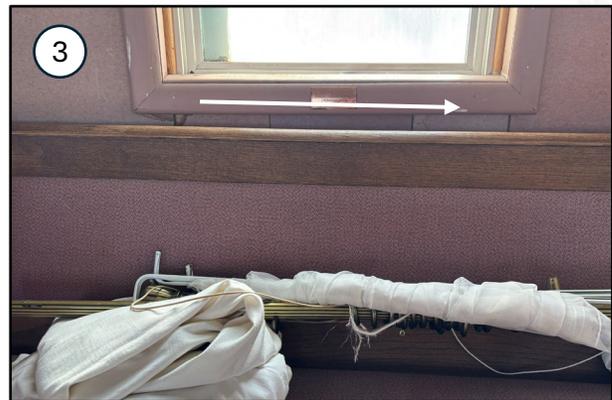
② **THE NAÏVE (SOUTH WEST CORNER)** is noticeably lower than the rest of the structure. When we placed a pew against a window it was evident that the floor is slope downward toward the South West. Similar to the storage room this corner of the building is experiencing differential settlement caused by foundation construction on shallow inadequately compacted fill. Water which has infiltrated the foundation over time is likely further reducing bearing capacity of soils which will continue to fail.

Church pew and floor are sloping, windowsill is level.

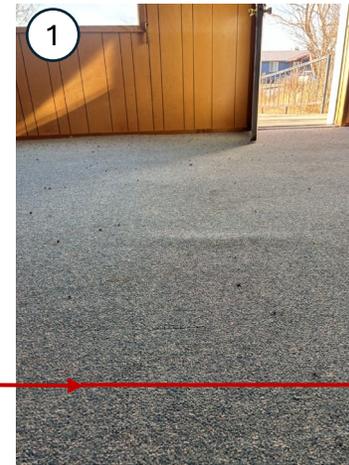
5 **FLOORS IN THE ASSEMBLY AREA** are “sponge” and sloping in various directions. The floor construction in this area of the building are mixed conc. slab and wood framing. The areas of concern are where the wood framing meets the slabs. These areas are noticeably uneven when viewed against a level surface like a door jamb or wall trim

Floor is sloping in multiple locations

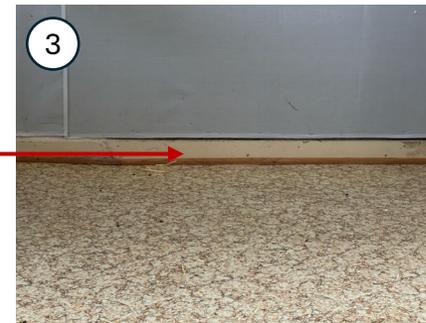
Wavy construction were floor changes to slab on grade

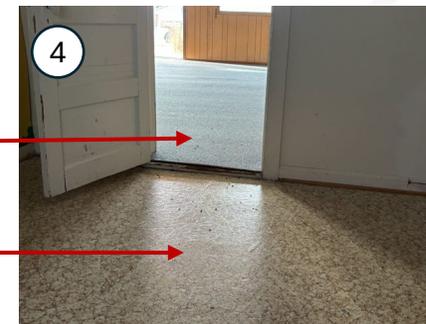
Wood floor over crawl space

Slab on Grade
