PROJECT OVERVIEW

On January 22nd 2026 Chris Egnatz (Architect) performed a comprehensive structural review of the Clyde Park Town Hall and (vacated) Methodist Church properties. The following report captures the site observations and structural assessment of both properties for the town's consideration.

STRUCTURAL OVERVIEW

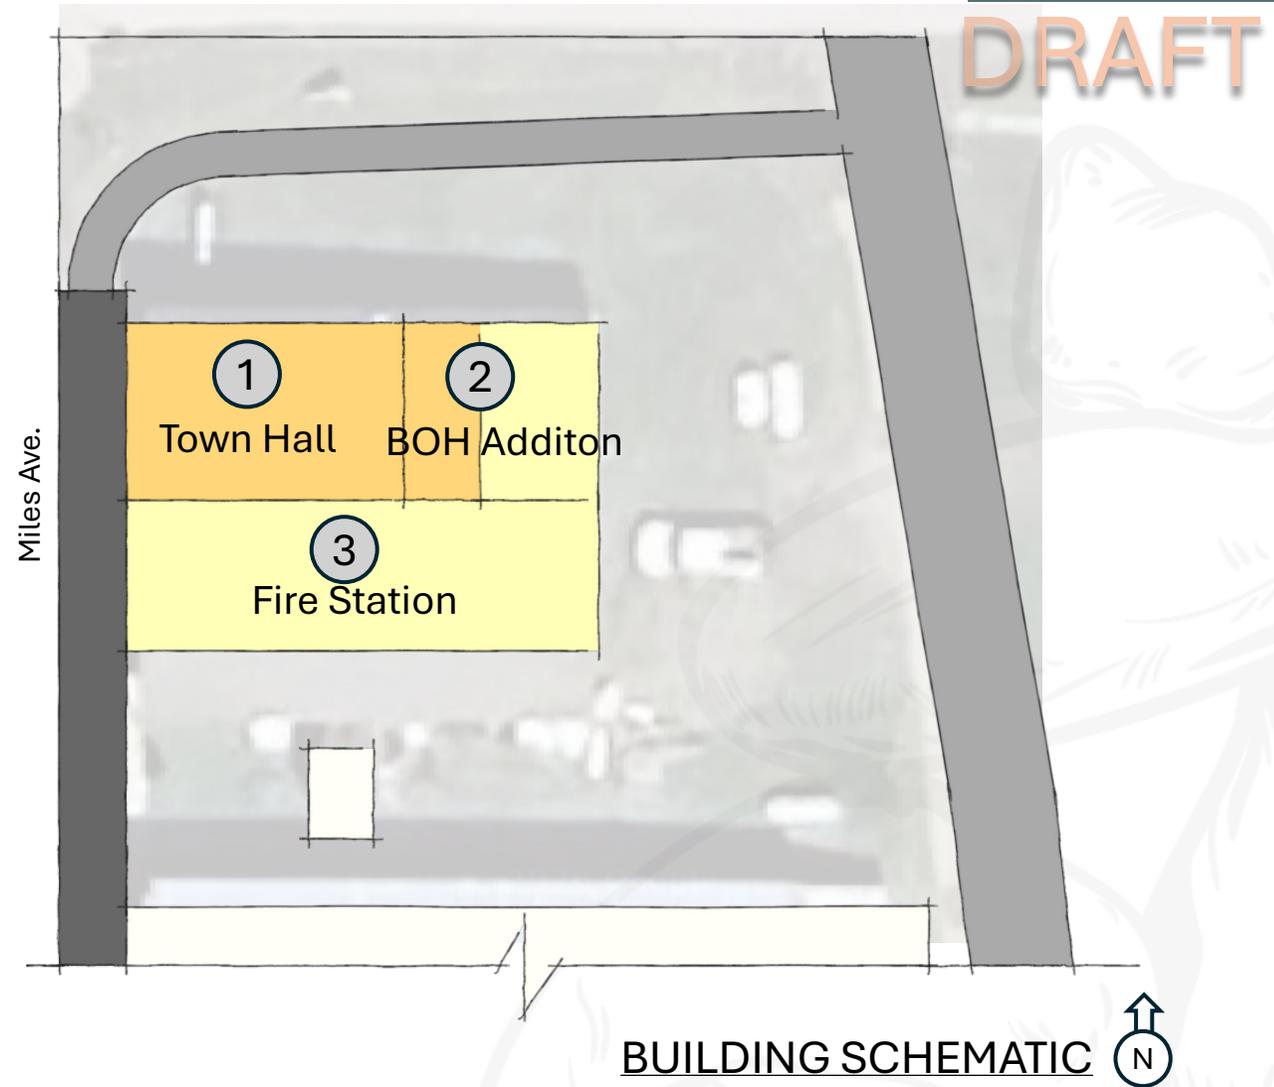
Clyde Park Town hall and Fire station were built as Type V (non sprinkler) wood construction in +/- 1905?. The original building housed the county courthouse and has been expanded on over the years. There are minimal records of the different additions added to the building, however the attached diagram helps summarize the different construction types which likely align with the various renovations.

- ① Wood Framing (Original Construction)
- ② Mixed Construction Wood Framing / Slab on Grade (BOH Addition 1)
- ③ Slab on Grade (Fire Station Addition 2)

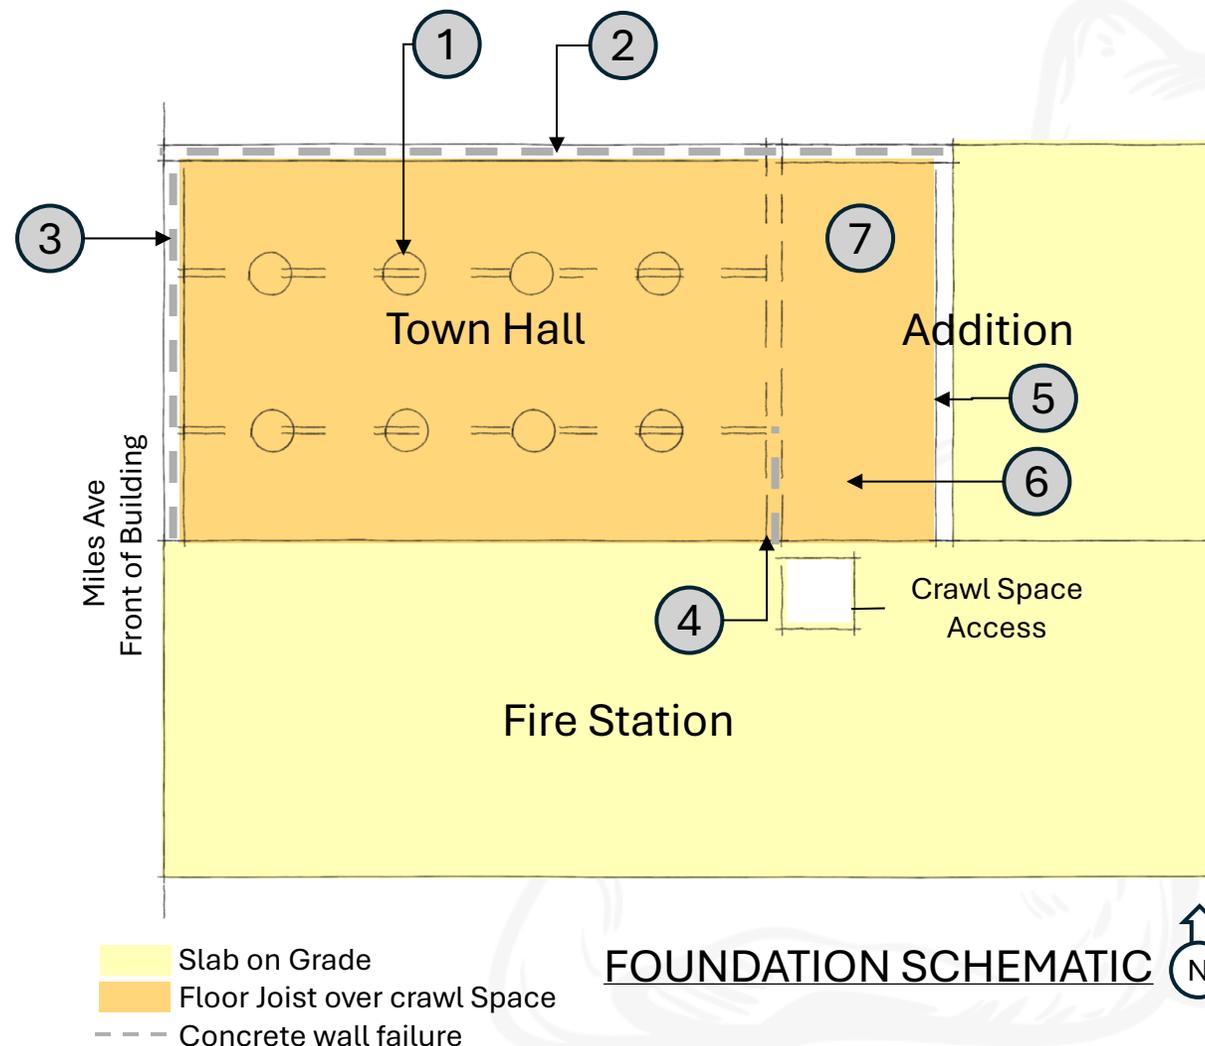
SUMMARY OF DEFICIENCIES

- ① The Floor joist in this area of the building are supported by retrofit beams. Precast manhole covers over non compacted fill. These should be pored footings on structural fill.
- ② The Concrete foundation walls on the North and West side of the building are failing.
- ③ Wood retainage for curb and sill (@ front of building) is undersized and beginning to decay.
- ④ The Cut foundation at building mid span I failing and framing is undersized to support floor above.
- ⑤ Non treated wood framing bearing on and encapsulated by dirt.
- ⑥ There are no footings to support structure here. Column rest on sloping fill.
- ⑦ There are no joist hangers support floor. Joist are toe nailed to beams and can fail under shear.

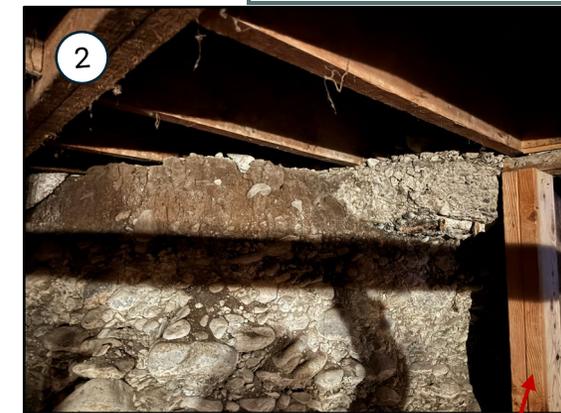
The foundation wall that supports the west side of the building was cut some time ago to gain access to the crawl space. Unfortunately, the foundation wall now non-structural and leaning in. Retrofit 2x6 framing is (hammered into place) and inadequate to support the floor loads above. Additionally, the fill supporting the fire station slab is falling into the crawl space creating a void space under the slab.

Door jack has been hammered into place to hold back fill from fire station.

Original foundation wall is now leaning into crawl space and is non-structural

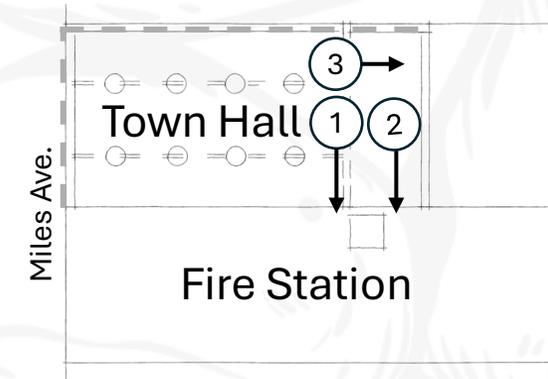
There is no vapor barrier located over the crawl space where wood member are in close proximity to dirt. In some instances untreated joist are laying on, or encapsulated in dirt. We could not gain access to review what the joist bear are bearing on (if anything). However; It can be assumed that compromised joist + lack of bearing are leading to the sloping floors found in the offices above.

Example wood floor framing sitting directly on dirt.

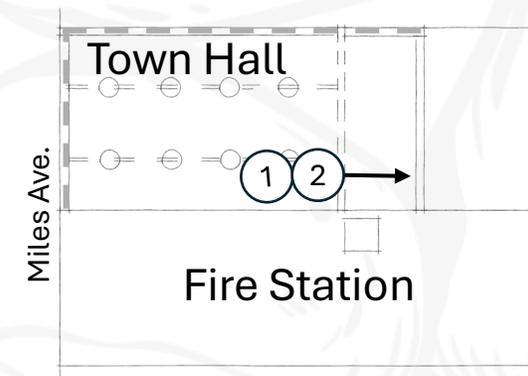
Some time in the past this floor framing was added which rests on the original foundation wall and dirt/fill to the east. Its important to note that framing in the area of the building is inadequate. Column are hammered into place on 2x4 blocks placed on non-structural slopping fill. All column should bear on Concrete footing / sono tubes and be treated.

Beam supported by 2x6 on non-structural fill

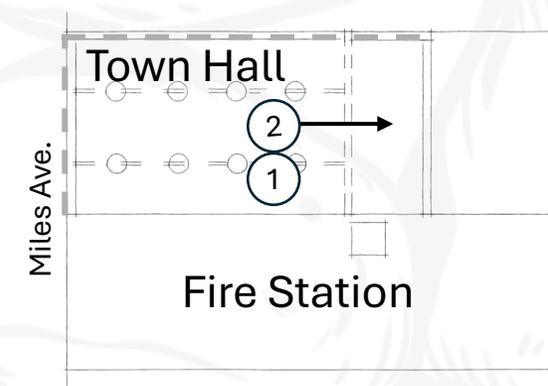
There are no joist hanger used in this area of the building. Joist have been toe nailed to beams with 8d and 16d framing nails. These fasteners can fail in shear over time from standards live loads above. Would recommend a review of wood joinery and the addition of joist hangers.

Floor joist toe nailed to beam. Fasteners can fail under shear with live load above

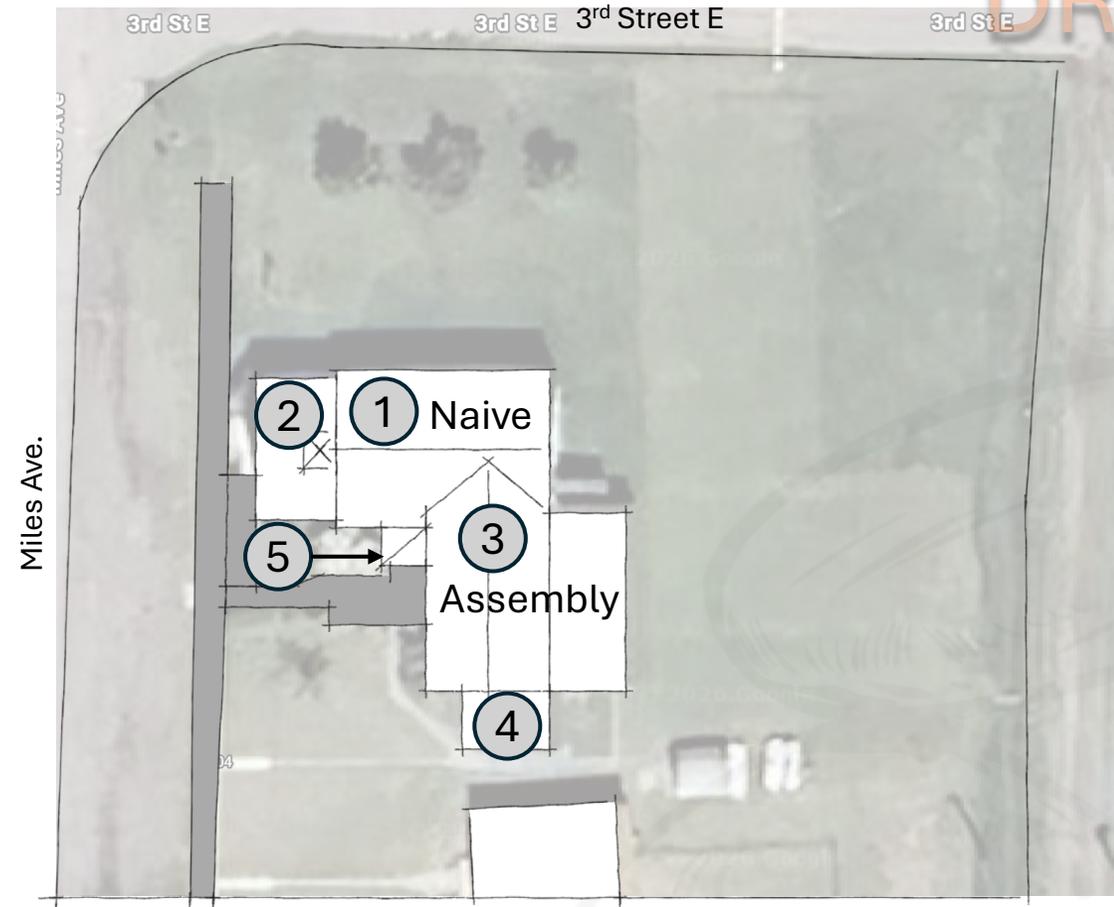
BUILDING SCHEMATIC

- ① The **Naïve** is the original 1905 wood construction. Floor construction is wood joist, walls and ceiling are Type V wood framed. *Note: The Crawl space in this area of the church was not accessible.*
- ② **Vestibule + Steeple** Floor construction is wood joist, walls and ceiling are Type V wood framed
- ③ The **Assemble and Kitchen** Floor construction is a mixture of slab on grade and wood joist.
- ④ The **Restrooms** Floor construction is wood joist, walls and ceiling are Type V wood framed
- ⑤ The **Storage Room** Floor construction is wood joist, walls and ceiling are Type V wood framed

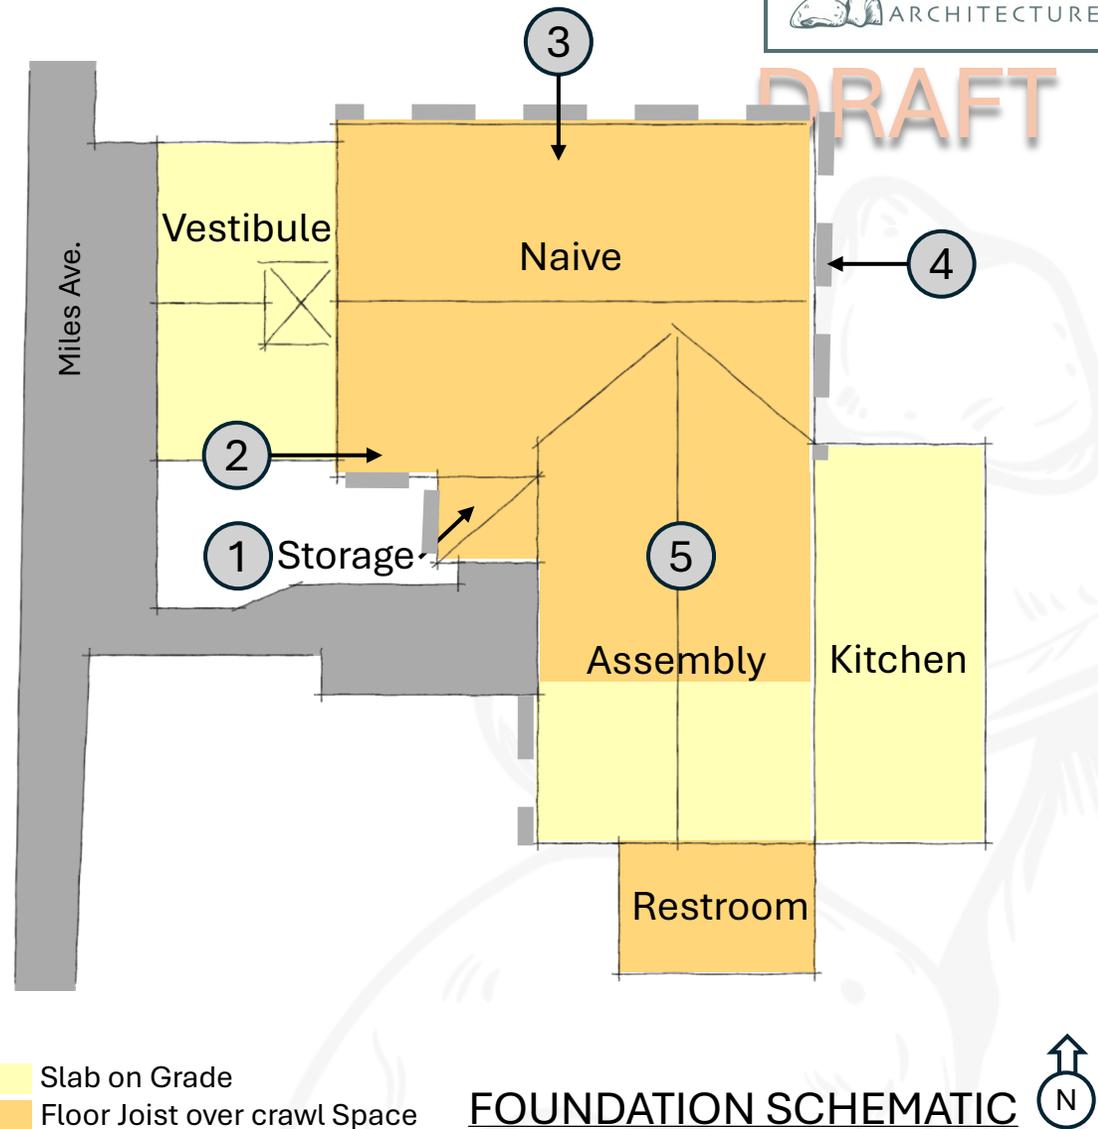
SUMMARY OF DEFICIENCIES

- ① The Storage Room adjacent to the entry has settled into the ground and is pulling away from the building.
- ② The South West Corner of the naïve is sinking into the ground due to differential settlement across the foundation
- ③ The North Wall of the naïve is leaning outward toward the park. This is pulling the roof trusses downward which is observed as an arch in the roof ridge.
- ④ There are many large cracks in the foundation likely cause by differential settlement over the years. Some of these cracks are likely causing water to infiltrate leading to further settlement.
- ⑤ The floor in the assembly area is spongee and sloping in different directions. Note: There were no slopes observed where this room becomes slab on grade.

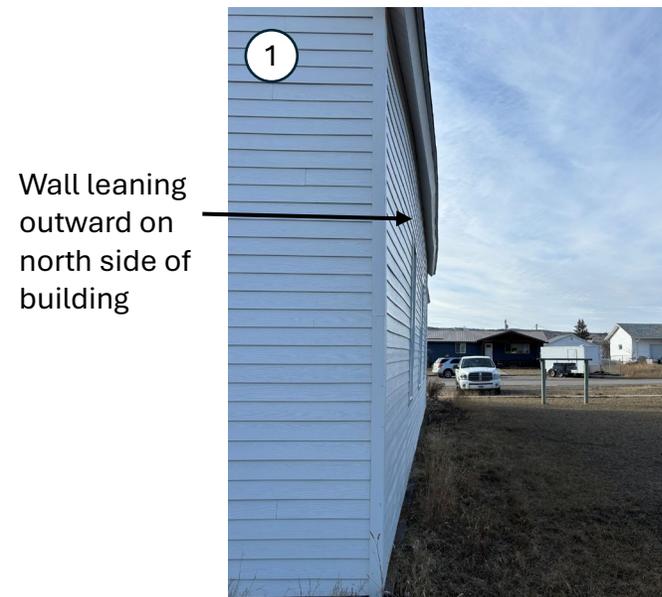
3 THE NAÏVE (NORTH WALL) is leaning outward toward the park. This is Observable as you look down the exterior wall and can be seen from the park as a Bow in the roof ridge. The roof trusses are fastened to the top plate of the wall, as the wall leans out the fasteners and framing members are stressed. This failure is noticeable as the aforementioned bow in the roof ridge seen from the park.

Large bow in roof ridge cause by exterior wall leaning outward

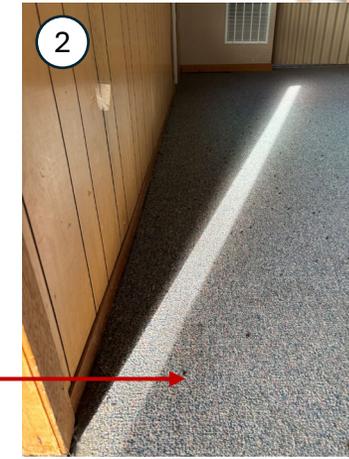
5 **FLOORS IN THE ASSEMBLY AREA** are “sponge” and sloping in various directions. The floor construction in this area of the building are mixed conc. slab and wood framing. The areas of concern are where the wood framing meets the slabs. These areas are noticeably uneven when viewed against a level surface like a door jamb or wall trim

Floor is sloping in multiple locations

Further investigation will be needed to better understand what happening below the floor. We can infer that there may be undersized framing or settlement happening where the crawl space meets the concrete slab construction.
